**Flood Control Project Maintenance  
Levee Inspections**

**Fall 2016 Levee Maintenance Deficiency Summary Report**

**Sacramento River Basin**

| <b>RD0010</b> | Overall LMA Rating | Total LMA Miles | * Overall LMA Threshold Percent is less than 10.00%; however, U Rated Miles are present, so the Overall LMA Rating is M instead of A. | | | | | |
|---|---|---|---|---|---|---|---|---|
| <b>Reclamation District No. 0010 Honcut</b> | <b>M *</b> | <b>21.82</b> | | | | | | |

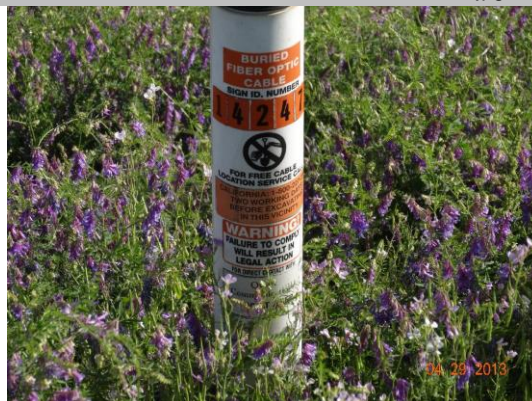
Photo 1 of 2 : UCIP\_FA\_2016\_27712\_51365.jpg

FS\_ID:27712  
DS\_ID:24653  
EP\_NO: N/A  
Repair Type: Non-Urgent  
Crossing Status: Indicator Found  
UCIP Comments: Need to contact owner--unable to determine if crossing is authorized (no permit found) also need to determine if crossing goes through levee.  
FIELD\_STRUCT\_DESC: Fiber optic line markers on levee slope unable to determine if line goes through levee.  
FS Date: 4/29/2013

Contact information for buried fiber optic cable.

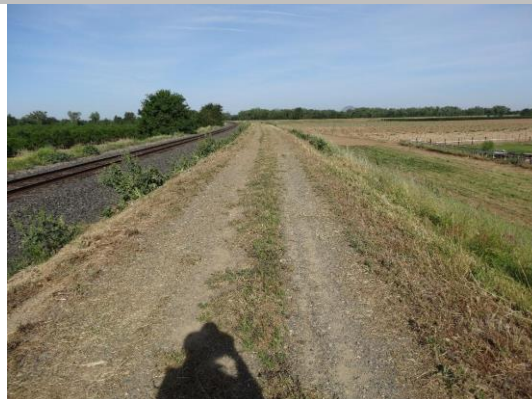
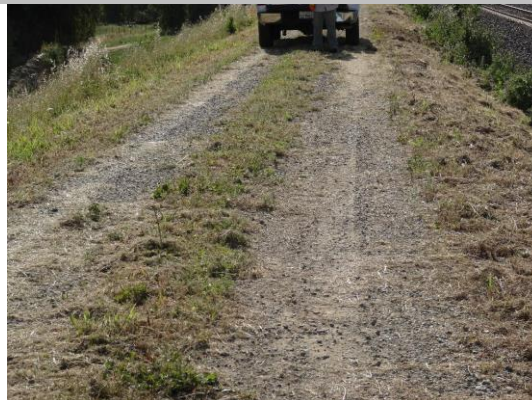
| FS_ID:24806<br>DS_ID:21257<br>EP_NO: 13015<br>Repair Type: Non-Urgent<br>Crossing Status: Found<br>UCIP Comments: New gravel indicates work was recently completed.<br>Will need to contact owner to obtain information pertaining to work completed. Need to contact owner to determine if crossing is still active and to determine last inspection date. Will need copy of letter showing crossings passed inspection. This crossing is referenced in the USACE Periodic Inspection as item USACE_CESPK_HON1_2013_p_0075.<br>FIELD_STRUCT_DESC: 4-inch pipe sleeved through an 8-inch pipe through the levee, 30.0 feet below the crown. Annular spaced grouted. Cutoff walls on both ends within the levee. (Permit No. 13015-1981)<br>FS Date: 4/29/2013 | | | | | |

View of levee crown looking upstream.

View of levee crown looking downstream.

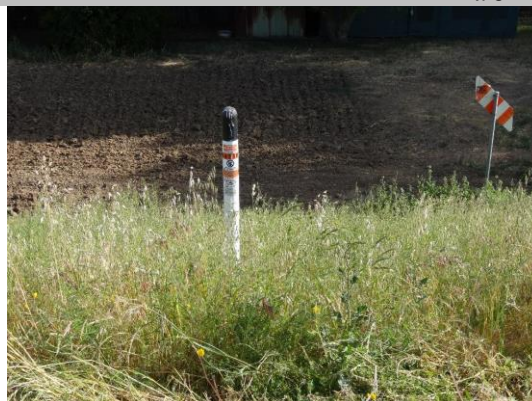
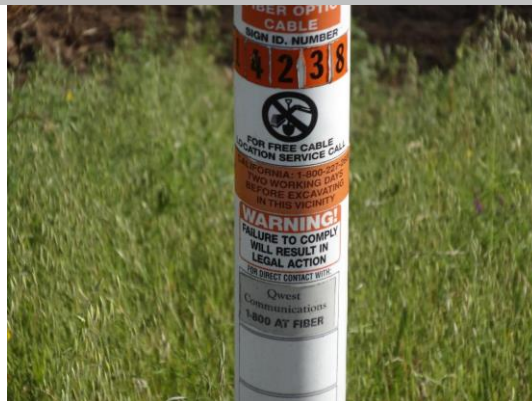
FS\_ID:27713  
DS\_ID:24654  
EP\_NO: N/A  
Repair Type: Non-Urgent  
Crossing Status: Indicator Found  
UCIP Comments: Need to contact owner--unable to determine if crossing is authorized (no permit found) also need to determine if crossing goes through levee.  
FIELD\_STRUCT\_DESC: Fiber optic line markers on levee slope unable to determine if line goes through levee.  
FS Date: 4/29/2013

View of landward side--communication line marker.

Contact information for communication line.

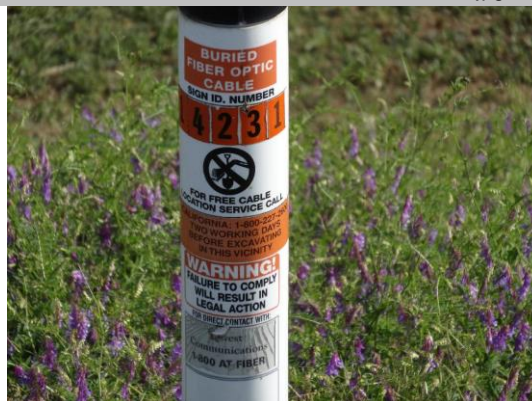
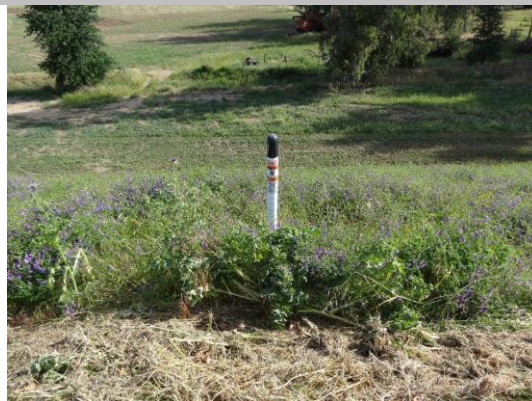
| FS_ID:27710<br>DS_ID:24655<br>EP_NO: N/A<br>Repair Type: Non-Urgent<br>Crossing Status: Indicator Found<br>UCIP Comments: Need to contact owner--unable to determine if crossing is authorized (no permit found) also need to determine if crossing goes through levee.<br>FIELD_STRUCT_DESC: Fiber optic line markers on levee slope unable to determine if line goes through levee.<br>FS Date: 4/29/2013 | | | | | |

Contact information for fiber optic cable and ID number.

View of marker located on landward side.

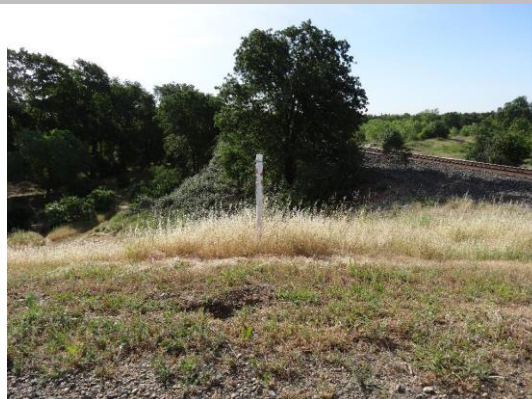
Photo 1 of 2 : UCIP\_FA\_2016\_27715\_51371.jpg

FS\_ID:27715  
DS\_ID:24656  
EP\_NO: N/A  
Repair Type: Non-Urgent  
Crossing Status: Indicator Found  
UCIP Comments: Need to contact owner--unable to determine if crossing is authorized (no permit found) also need to determine if crossing goes through levee.  
FIELD\_STRUCT\_DESC: Fiber optic line markers on levee slope unable to determine if line goes through levee.  
FS Date: 4/29/2013

View of marker located on waterward side.

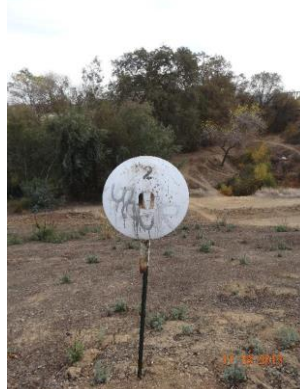
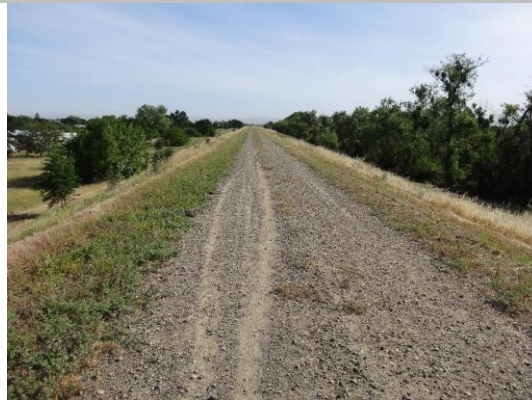
FS\_ID:50058  
DS\_ID:21258  
EP\_NO: N/A  
Repair Type: Non-Urgent  
Crossing Status: Found  
UCIP Comments: 7/01/2016 Gate has been repaired--WS gate is functional. LS gate still needs new stem for the gate to properly function--stem is bent. USACE's PI issue references permit number 13710 this is incorrect permit is associated with DS\_ID 21259 (CLM 0.767). (DWR UCIP - omagana)4/29/2013 Damaged flap gate on waterward side and damaged stem on screw gate on landward side. Need to contact owner to determine if crossing is still active. If crossing is still in use owner will need to address damage on flap gate and screw gate. If crossing is no longer in use owner will need to contact the CVFPB to comply with Title 23. This crossing is referenced in the USACE Periodic Inspection as item USACE\_CESPK\_HON1\_2013\_p\_0053 and 0057. (DWR UCIP - omagana)  
FIELD\_STRUCT\_DESC: 24-inch corrugated metal drainage pipe through the levee, 31 feet below the crown. Two corrugated metal cutoff walls around pipe and concrete headwall at both ends. Flap gate is located on the waterside (WS) end. Slide gate is located on the landside (LS) end. Pipe discharges into 6-foot concrete splash apron located on the WS. [Additional Reference(s): DWR Levee Log, 2005. USACE Sacramento O&M Manual Unit No. 151, May 1953, Station 46+60].

View of WS--Marker indicates crossing is labelled as 2.

View of levee crown looking downstream.

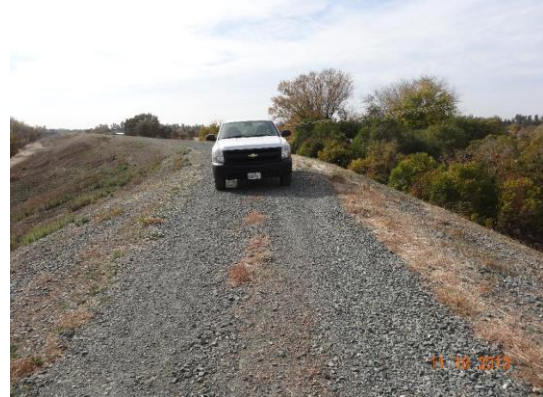
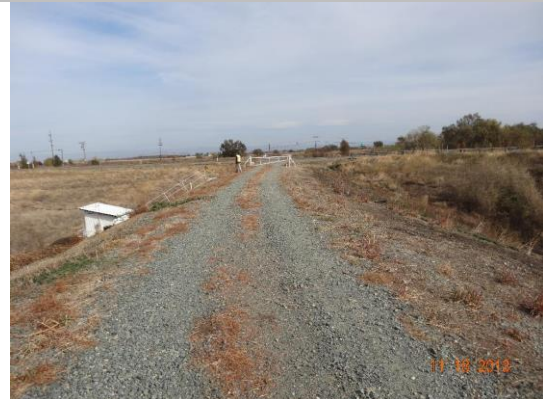
FS\_ID:27725  
DS\_ID:21262  
EP\_NO: N/A  
Repair Type: Non-Urgent  
Crossing Status: Found  
UCIP Comments: Crossing appears not to be in use--need to contact owner. Need to coordinate with owner to determine status of crossing. If crossing is no longer in use owner will need to contact the CVFPB to comply with Title 23. This crossing is referenced in the USACE Periodic Inspection as item USACE\_CESPK\_HON1\_2013\_p\_0012.  
FIELD\_STRUCT\_DESC: 10-inch steel pipe through the levee, 7.3 feet below the crown. Siphon breaker in CM riser on the waterward slope. Pump on the waterward berm-pump not present. Switch house on the waterward slope-no switch house present. 24-inch concrete standpipe at the landward toe. (USACE-1955). This entry matches the Drainage or Irrigation Structure referenced in O&M manual (Station 14+82). Concrete pad is still present on waterward side.  
FS Date: 4/29/2013

View of levee crown looking upstream.

View of levee crown looking downstream.

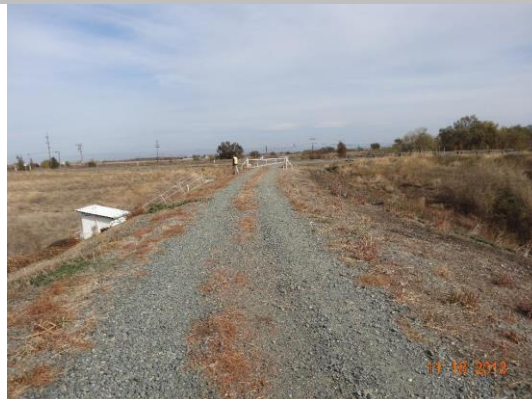
FS\_ID:24810  
DS\_ID:21263  
EP\_NO: N/A  
Repair Type: Non-Urgent  
Crossing Status: Found  
UCIP Comments: Pipe has been capped on waterward side--see photos. Need to coordinate with DWR Inspector to determine whether crossing is compliant with Title 23. This crossing is referenced in the USACE Periodic Inspection as item USACE\_CESPK\_HON1\_2013\_p\_0016.  
FIELD\_STRUCT\_DESC: 10-inch steel pipe through the levee, 6.8 feet below the crown. Steel cutoff plate around pipe at center of levee. Siphon breaker in CM riser on the waterward slope. Pump on concrete base on the waterward berm-not present. 36-inch concrete standpipe at the landward toe. Metal shed and service pole on the waterward slope-not present. (USACE-1955). This entry matches the Drainage or Irrigation Structure referenced in O&M manual (Station 14+16).  
FS Date: 4/29/2013

View of levee crown lookin upstream.

View of levee crown looking downstream.

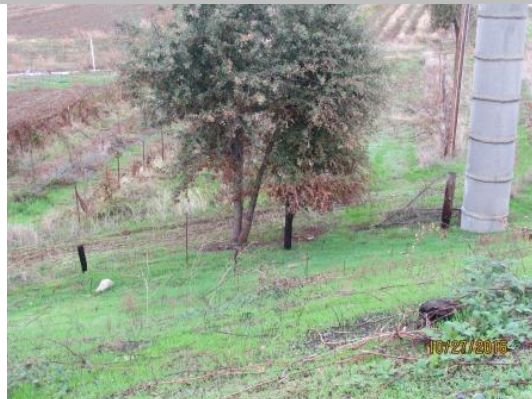
Photo 1 of 1 : FA\_2016\_RD0010\_163\_2\_20161031\_00071.jpg

| Tree limbs have been trimmed up for visibility and access. Fall 2016. | | | | | |

View of tree that has been trimmed up for visibility and access on the landside. Fall 2016.

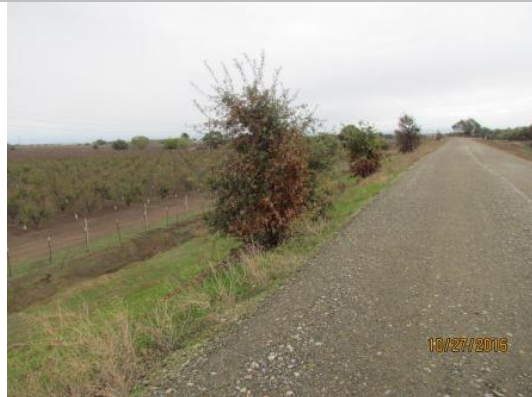
Photo 1 of 1 : FA\_2016\_RD0010\_163\_67\_20161031\_00072.jpg

View of a small tree that needs to be removed on the land side slope looking upstream. Fall 2016.

| Small starter tree should be removed. Fall 2016. | | | | | |

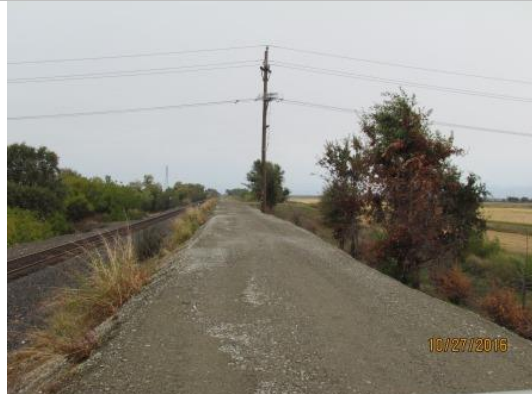
Photo 1 of 1 : FA\_2016\_RD0010\_163\_66\_20161031\_00073.jpg

View of a small tree that needs to be trimmed for visibility and access on the land side slope looking upstream. Fall 2016.

| Small trees should be trimmed up for visibility and access. Fall 2016. | | | | | |

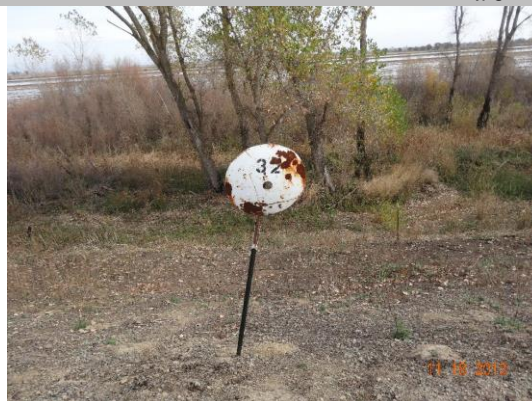
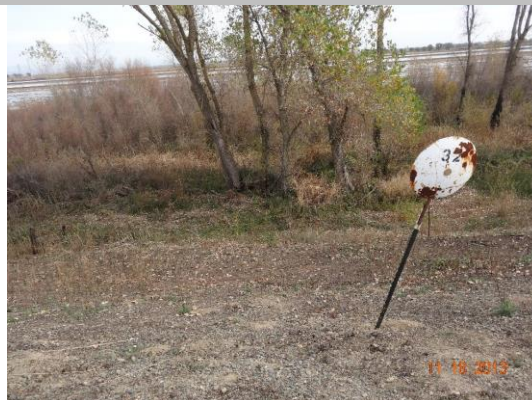
View of marker visible on waterward shoulder.

View of waterward slope.

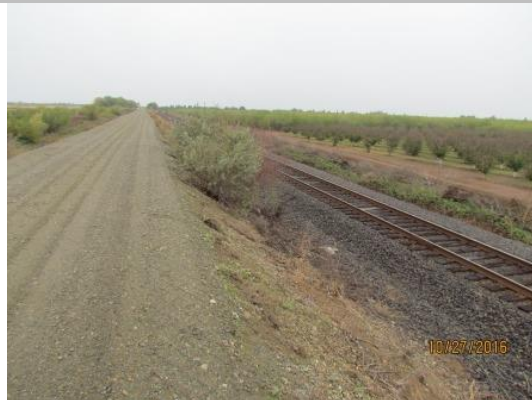
Photo 1 of 1 : FA\_2016\_RD0010\_163\_47\_20161031\_00087.jpg

View of a small willow tree that should be removed on the landside looking down stream. Fall 2016.

| Remove small willow tree from levee slope. Fall 2016. | | | | | |

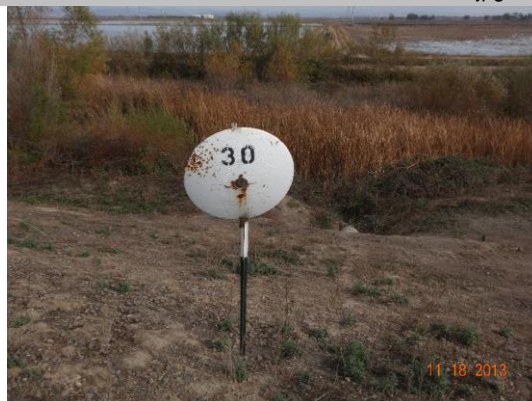
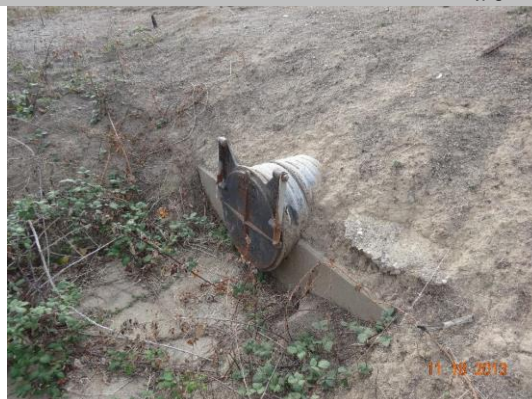
| FS_ID:27747<br>DS_ID:21274<br>EP_NO: N/A<br>Repair Type: Non-Urgent<br>Crossing Status: Indicator Found<br>UCIP Comments: sign marker on WS 30; Unable to confirm landward side. This crossing is referenced in the USACE Periodic Inspection as item USACE_CESPK_HON1_2013_p_0232.<br>FIELD_STRUCT_DESC: 24-inch CM drainpipe through the levee, 18.0 feet below the crown. CM cutoff wall around pipe at center of levee. Flap gate and splash apron (6x6 foot) on the waterward end. (USACE-1953). This entry matches the Drainage or Irrigation Structure referenced in O&M manual (Station 339+55.10).<br>FS Date: 4/29/2013 | | | | | |

View of waterward side--marker indicating crossing located on waterward shoulder.

View of pipe, flap gate, and headwall located on waterward toe.

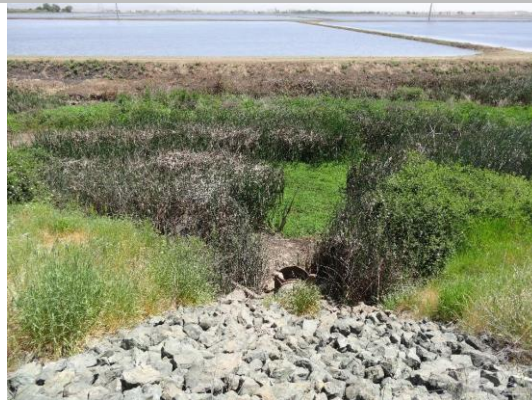
Marker for pipe crossing visible on WS shoulder.

View of WS during April.

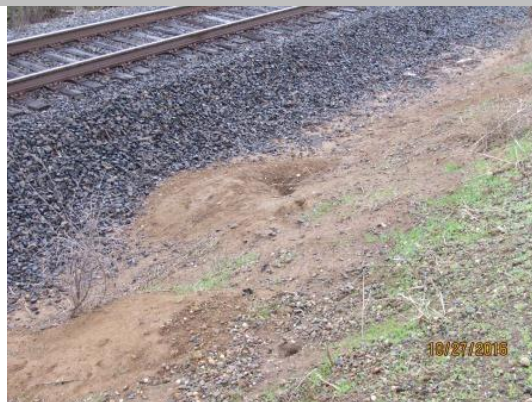
Photo 1 of 1 : FA\_2016\_RD0010\_163\_42\_20161031\_00091.jpg

View of squirrel hole on landside toe, no sign of activity. Fall 2016.

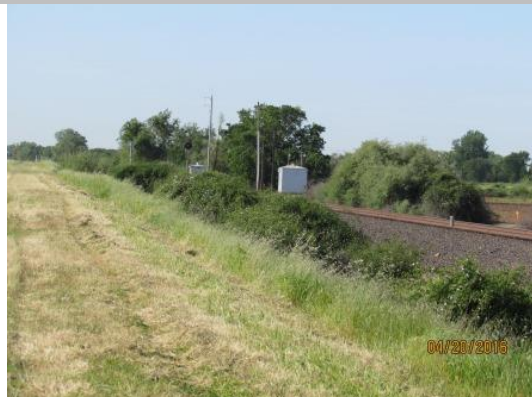
Photo 1 of 2 : FA\_2016\_RD0010\_163\_36\_20160906\_00013.jpg

View looking downstream landside of wild rosebushes that are blocking visibility at the toe. Spring 2016.

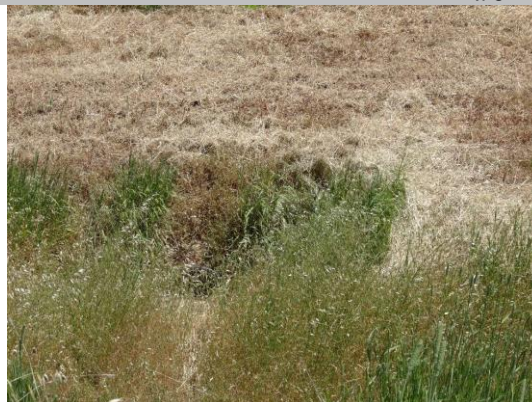
Marker visible on waterward shoulder.

View of waterward toe where pipe daylighting.

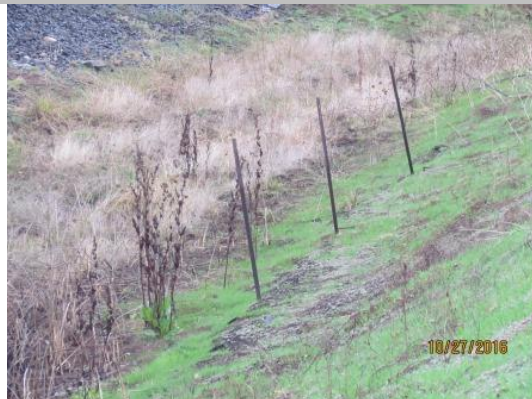
Photo 1 of 1 : FA\_2016\_RD0010\_163\_33\_20161031\_00094.jpg

View of fence post that run along the landside levee toe, looking upstream. Fall 2016.

| Fence t-post at levee toe should be removed. Fall 2016. | | | | | |

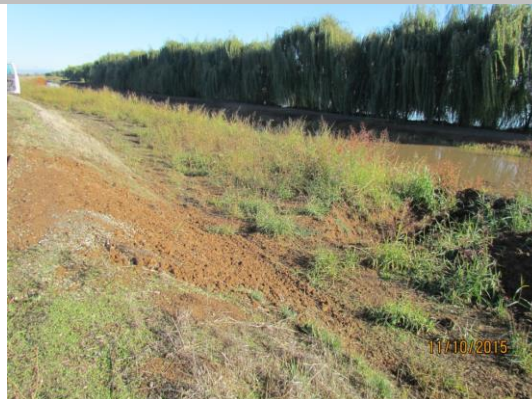
Photo 2 of 4 : FA\_2016\_RD0010\_163\_27\_20160906\_00003.jpg

View of the trench on the waterward side of the levee looking upstream. Works seem to have been done on the levee slope as well. Fall 2015.

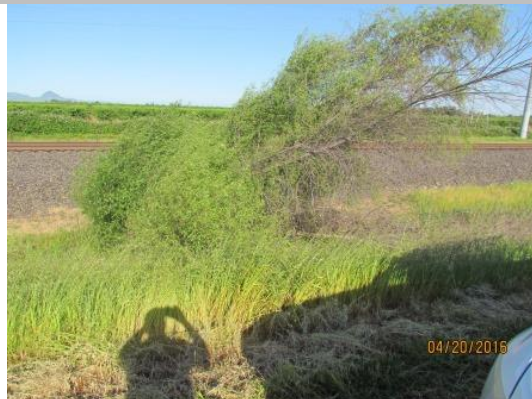
Photo 1 of 2 : FA\_2016\_RD0010\_163\_32\_20160906\_00011.jpg

View of a tree that needs to be removed. Small trees 4" in diameter at chest height should be removed before they get to big. View of landside. Spring 2016.

| Small trees 4" in diameter at chest height should be removed before they get to big. | | | | | |

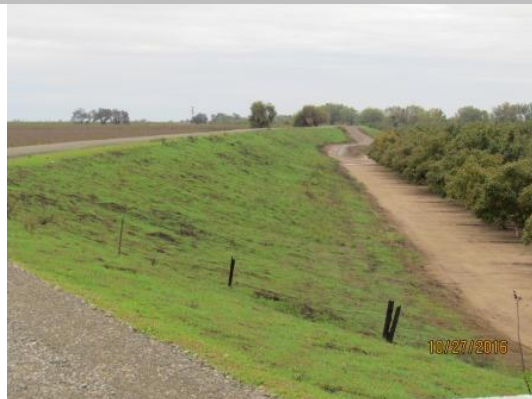
Photo 1 of 1 : FA\_2016\_RD0010\_164\_48\_20161031\_00068.jpg

| Well maintained annual vegetation. Fall 2016. | | | | | |

View of well maintained annual vegetation on the waterside looking downstream. Fall 2016.

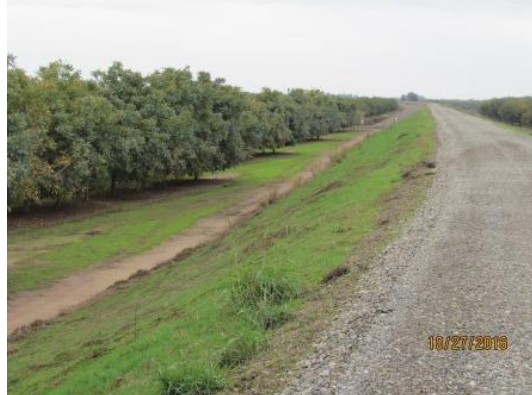
Photo 1 of 1 : FA\_2016\_RD0010\_164\_24\_20161031\_00069.jpg

| Well maintained annual vegetation. Fall 2016. | | | | | |

View of well maintained annual vegetation on the landside looking downstream. Fall 2016.

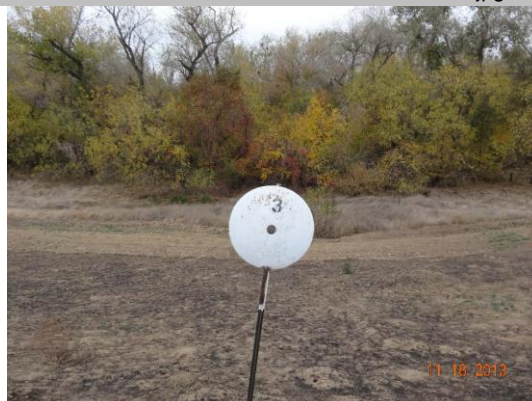
Photo 1 of 2 : UCIP\_FA\_2016\_27533\_51135.jpg

| FS_ID:27533<br>DS_ID:21280<br>EP_NO: N/A<br>Repair Type: Non-Urgent<br>Crossing Status: Found<br>UCIP Comments: Recommend removing vegetation and debris along pipe alignment (debris blocking gate on waterward side and vegetation blocking access to screw gate on landward side). Need to coordinate with owner to determine status of crossing. If crossing is no longer in use owner will need to contact the CVFPB to comply with Title 23. This crossing is referenced in the USACE Periodic Inspection as item USACE_CESPK_HON2_2013_p_0027.<br>FIELD_STRUCT_DESC: 24-inch CM pipe through the levee, 25.6 feet below the crown. Two CM cutoff walls around pipe at both shoulders. Flap gate on the waterward end. Concrete headwall, saddle and apron on the waterward end. (USACE-1953). This entry matches the Drainage or Irrigation Structure referenced in O&M manual (Station 106+00).<br>FS Date: 4/30/2013 | | | | | |

View of waterward side.

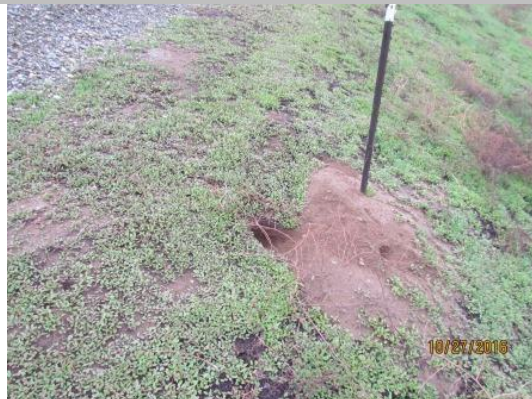
Photo 2 of 2 : FA\_2016\_RD0010\_164\_28\_20161031\_00070.jpg

| No rodent activity but squirrel hole needs to be backfilled. Fall 2016. | | | | | | |

View of squirrel hole on the waterside looking downstream. Fall 2016

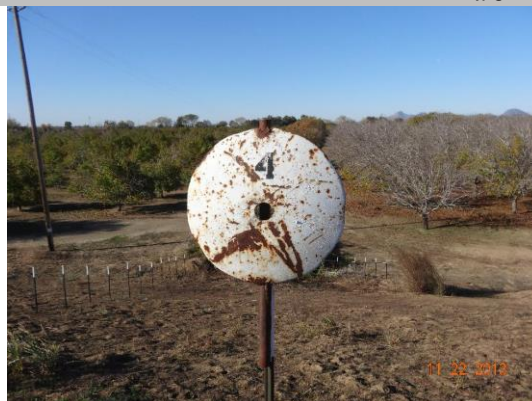
Photo 1 of 2 : UCIP\_FA\_2016\_24821\_44640.jpg

| FS_ID:24821<br>DS_ID:21281<br>EP_NO: N/A<br>Repair Type: Non-Urgent<br>Crossing Status: Found<br>UCIP Comments: Screw gate on landward side is blocked by sediment. Recommend removing sediment in front of gate. This crossing is referenced in the USACE Periodic Inspection as item USACE_CESPK_HON2_2013_p_0082.<br>FIELD_STRUCT_DESC: 24-inch CM pipe through the levee, 26.0 feet below the crown. Two CM cutoff walls around pipe at both shoulders. Flap gate on the waterward end. Slide gate on landward end. Concrete headwall, saddle and apron on the waterward end. (USACE-1953). This entry matches the Drainage or Irrigation Structure referenced in O&M manual (Station 149+88).<br>FS Date: 4/30/2013 | | | | | |

Marker visible on waterward side--No. 4.

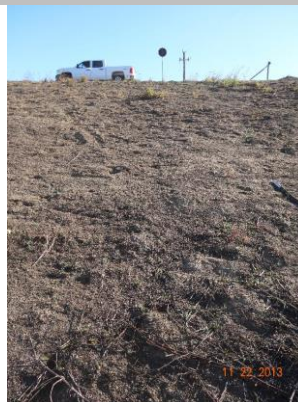
Photo 2 of 2 : UCIP\_FA\_2016\_24821\_44639.jpg

View of waterward slope side.

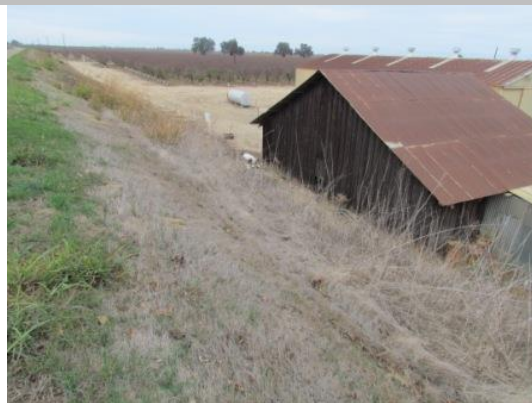
Photo 1 of 1 : FA\_2016\_RD0010\_164\_65\_20160906\_00013.jpg

| Unpermitted building at landside levee toe. Fall 2016. | | | | | |

This photo was taken from the crown facing north looking down the landward levee slope at an outbuilding near the levee toe. Fall 2013.

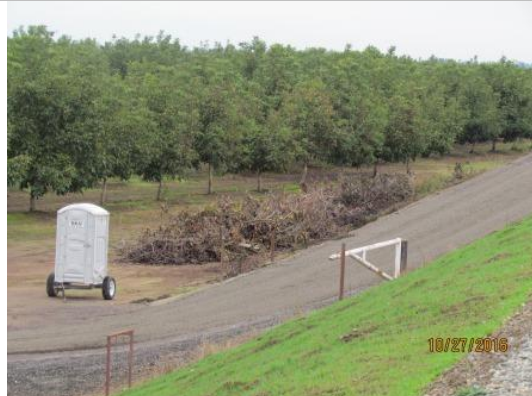
Photo 1 of 1 : FA\_2016\_RD0010\_164\_42\_20161031\_00077.jpg

View of pruning's at the landside toe looking downstream. Fall 2016.

| Remove pruning's from toe. Fall 2016. | | | | | |

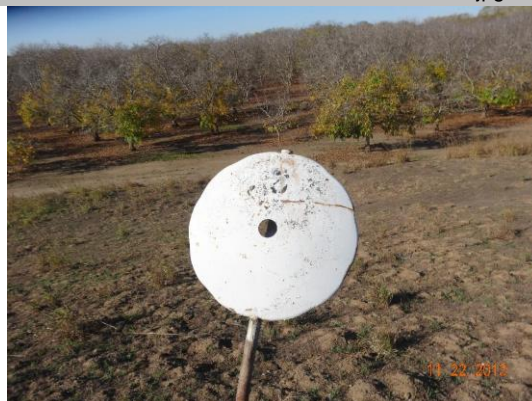
Photo 1 of 2 : UCIP\_FA\_2016\_27773\_51461.jpg

Marker visible on waterward side.

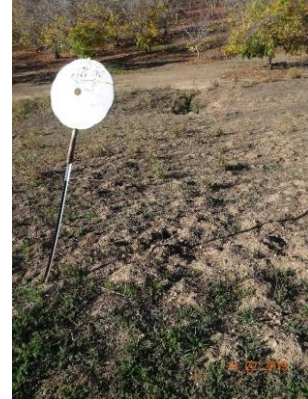
Photo 2 of 2 : UCIP\_FA\_2016\_27773\_51460.jpg

View of waterward side--burrow activity present on slope.

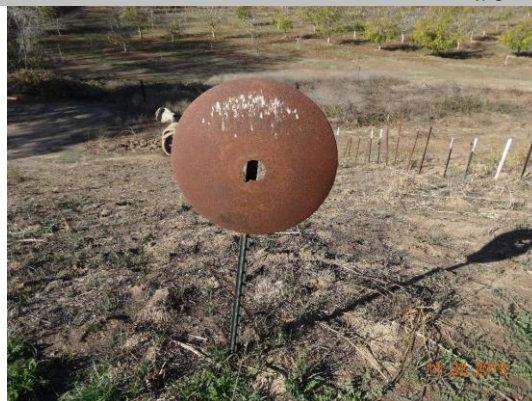
Photo 1 of 2 : UCIP\_FA\_2016\_24824\_44658.jpg

| FS_ID:24824<br>DS_ID:21284<br>EP_NO: N/A<br>Repair Type: Non-Urgent<br>Crossing Status: Found<br>UCIP Comments: Remove concrete piece preventing complete closure of screw gate on landward side. This crossing is referenced in the USACE Periodic Inspection as item USACE_CESPK_HON2_2013_p_0152.<br>FIELD_STRUCT_DESC: 36-inch CM drainpipe through the levee, 24.0 feet below the crown. Two CM cutoff walls around pipe at both shoulders. Flap gate on the waterward end. Slide gate on the landward end. Concrete headwalls at both ends. (USACE-1953). This entry matches the Drainage or Irrigation Structure referenced in O&M manual (Station 259+76).<br>FS Date: 4/30/2013 | | | | | |

Marker visible on waterward side.

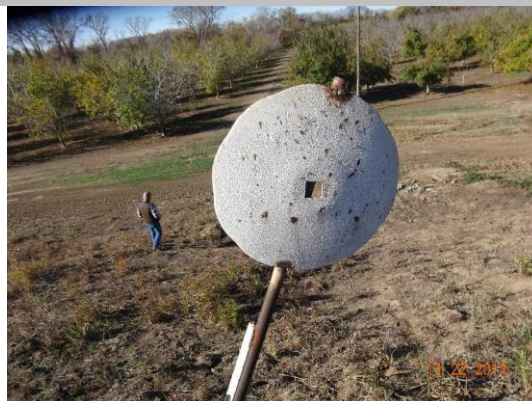
Photo 1 of 3 : FA\_2016\_RD0010\_164\_7\_20160906\_00001.jpg

Marker visible on waterward side.

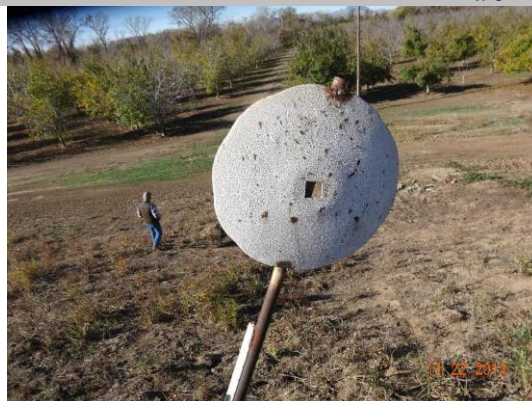
Photo 1 of 2 : UCIP\_FA\_2016\_24825\_44664.jpg

| FS_ID:24825<br>DS_ID:21285<br>EP_NO: N/A<br>Repair Type: Non-Urgent<br>Crossing Status: Found<br>UCIP Comments: Sediment blocking flap gate and screw gate--recommend removing material. Dense burrow activity present along levee slopes (large holes visible on landward side)--recommend addressing issue. This crossing is referenced in the USACE Periodic Inspection as item USACE_CESPK_HON2_2013_p_0169.<br>FIELD_STRUCT_DESC: 30-inch CM drainpipe through the levee, 19.5 feet below the crown. Two CM cutoff walls around pipe at both shoulders. Flap gate on the waterward end. Slide gate on the landward end. Concrete headwalls at both ends. (USACE-1953). This entry matches the Drainage or Irrigation Structure referenced in O&M manual (Station 277+00).<br>FS Date: 4/30/2013 | | | | | |

Marker visible on waterward side.

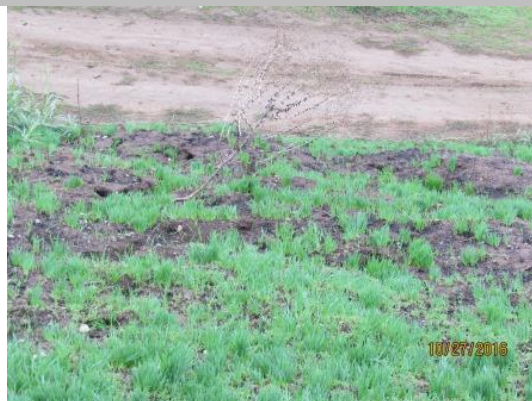
Photo 1 of 1 : FA\_2016\_RD0010\_164\_68\_20161031\_00079.jpg

| No rodent activity but holes need to be properly backfilled. Fall 2016. | | | | | |

View of rodent holes on waterside slope. Fall 2016.

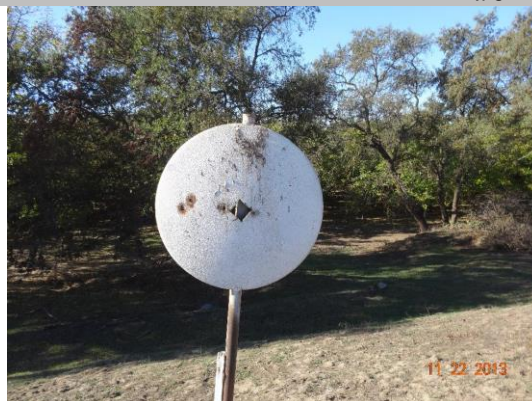
Photo 1 of 2 : UCIP\_FA\_2016\_24826\_44669.jpg

| UCIP Comments: Deformation observed on the top wall of pipe at the entrance of landward side--need to contact owner to address issue. | | | | | |

View of marker located on waterward shoulder, no reference number is visible.

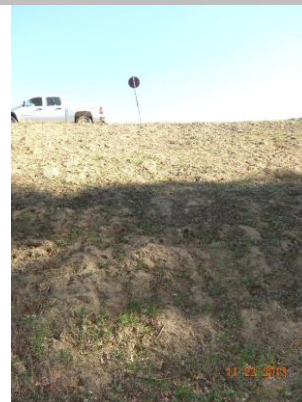
Photo 2 of 2 : UCIP\_FA\_2016\_24826\_44668.jpg

View of waterward slope.

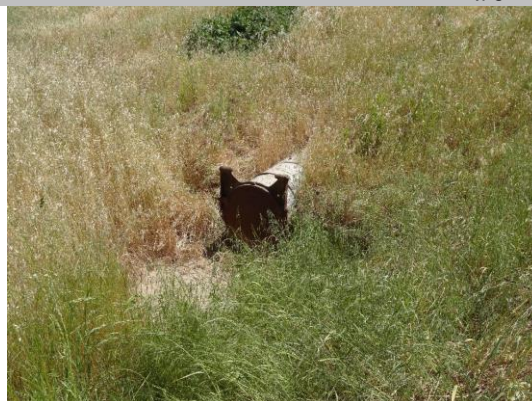
Photo 2 of 2 : UCIP\_FA\_2016\_24751\_44376.jpg

| FS_ID:24751<br>DS_ID:21288<br>EP_NO: N/A<br>Repair Type: Non-Urgent<br>Crossing Status: Found<br>UCIP Comments: Need to updated photos showing cleared slopes. This crossing is referenced in the USACE Periodic Inspection as item USACE_CESPK_HON2_2013_p_0193.<br>FIELD_STRUCT_DESC: 24-inch CM drainpipe through the levee, 19.0 feet below the crown. Two CM cutoff walls around pipe at both shoulders. Flap gate on the waterward end. Slide gate on the landward side. Concrete headwall, saddle and apron on the waterward end. (USACE-1953). This entry matches the Drainage or Irrigation Structure referenced in O&M manual (Station 322+25).<br>FS Date: 4/30/2013 | | | | | | |

View of flap gate on waterward side.

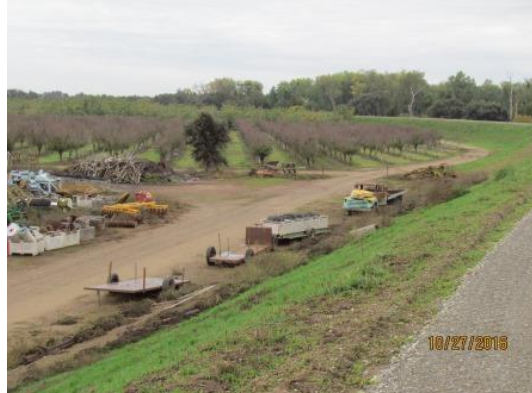
Photo 2 of 2 : FA\_2016\_RD0010\_164\_31\_20161031\_00081.jpg

View of the equipment at the toe of the levee on the landward side of the levee looking downstream. Fall 2016.

| Remove equipment from levee toe. Fall 2016. | | | | | | |

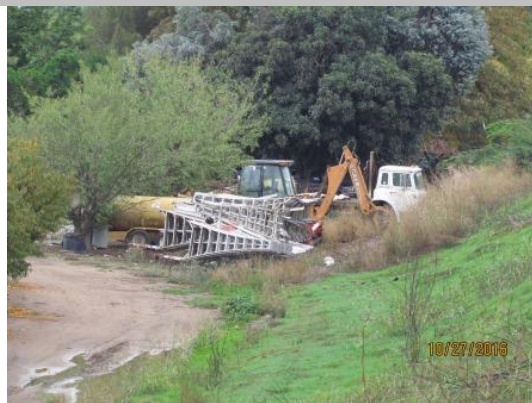
Photo 1 of 1 : FA\_2016\_RD0010\_164\_63\_20161031\_00084.jpg

View of the equipment at the toe of the levee on the landward side of the levee looking downstream. Fall 2016.

| Remove equipment from levee toe. Fall 2016. | | | | | |

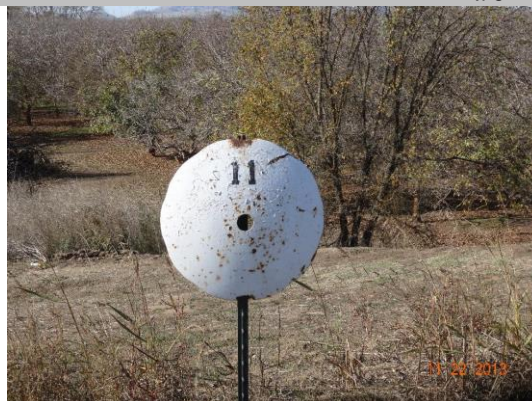
Photo 1 of 2 : UCIP\_FA\_2016\_27774\_51467.jpg

Marker visible on waterward shoulder, Reference ID No. 11 for crossing.

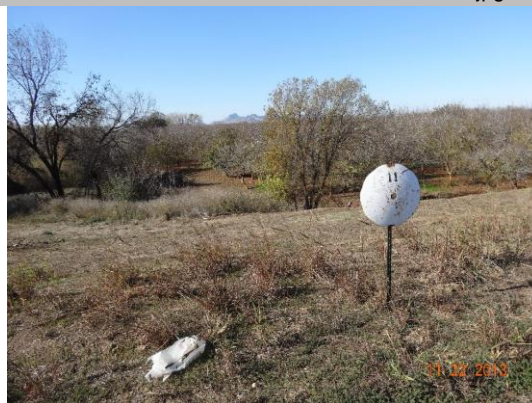
Photo 2 of 2 : UCIP\_FA\_2016\_27774\_51470.jpg

View of waterward side.

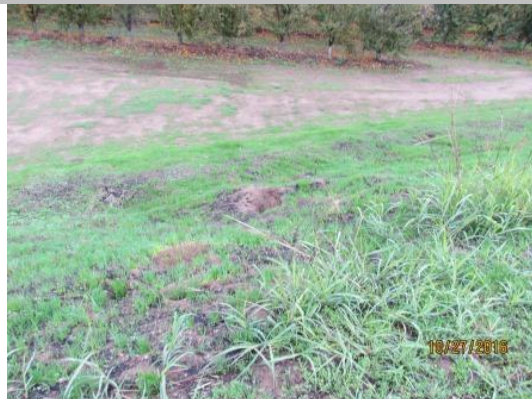
Photo 1 of 1 : FA\_2016\_RD0010\_164\_50\_20161031\_00087.jpg

| No rodent activity but holes need to be properly backfilled. Fall 2016. | | | | | |

View of rodent hole on landside slope. Fall 2016.

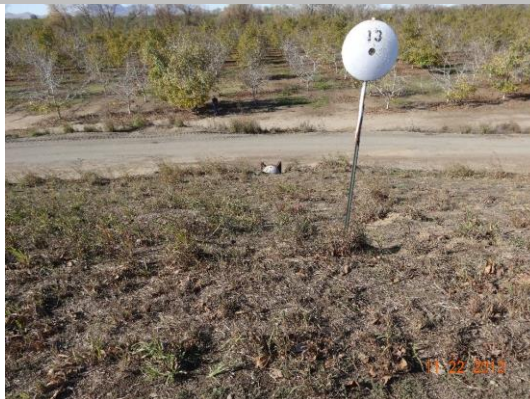
Photo 1 of 2 : UCIP\_FA\_2016\_27793\_51514.jpg

View of marker located on waterward shoulder, pipe is reference as No. 13.

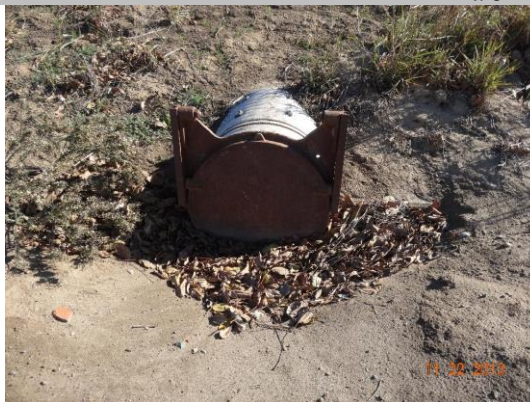
Photo 2 of 2 : UCIP\_FA\_2016\_27793\_51517.jpg

View of flap gate located on waterward side.

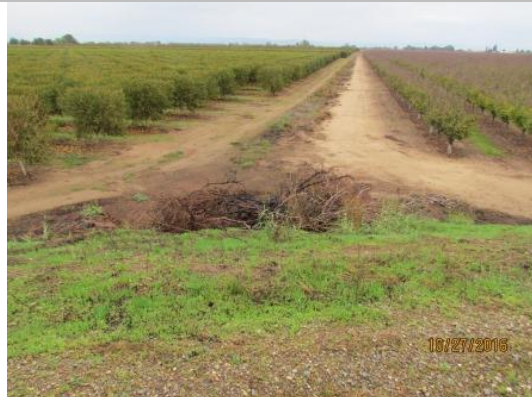
Photo 1 of 1 : FA\_2016\_RD0010\_164\_49\_20161031\_00089.jpg

View of pruning's at landside levee toe. Fall 2016.

| Remove pruning's, Fall 2016. | | | | | |

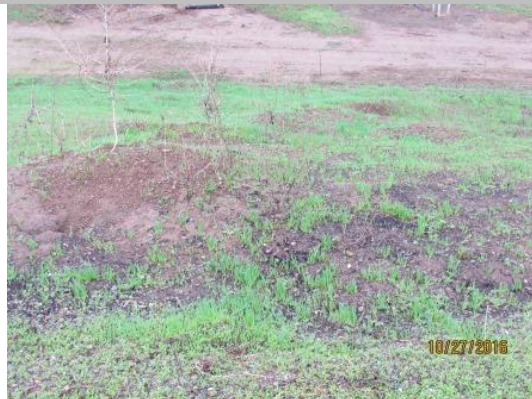
Photo 1 of 1 : FA\_2016\_RD0010\_164\_32\_20161031\_00092.jpg

| No rodent activity but holes need to be properly backfilled. Fall 2016. | | | | | |

View of rodent holes on waterside levee slope. Fall 2016.

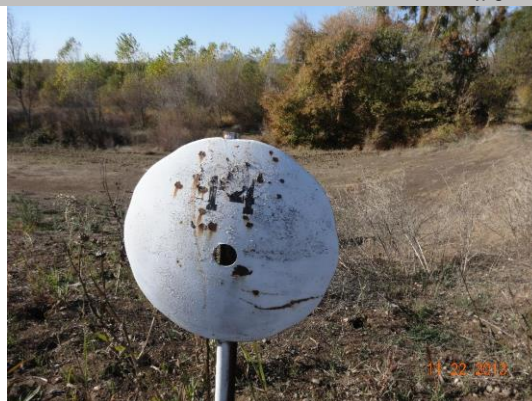
Photo 1 of 2 : UCIP\_FA\_2016\_50059\_44693.jpg

FS\_ID:50059  
DS\_ID:21293  
EP\_NO: N/A  
Repair Type: Non-Urgent  
Crossing Status: Indicator Found  
UCIP Comments: 7/01/2016 Crossing is blocked by sediment and debris on both WS and LS. Screw gate is missing on LS. (DWR UCIP - omagana)4/30/2013 Both openings of crossing are blocked by sediment--screw gate is damage. Recommend notifying owner to repair screw gate and remove sediment build-up blocking openings. This crossing is referenced in the USACE Periodic Inspection as item USACE\_CESPK\_HON2\_2013\_p\_0295. (DWR UCIP - omagana)  
FIELD\_STRUCT\_DESC: 24-inch corrugated metal drainage pipe through the levee, 13 feet below the crown. Two corrugated metal cutoff walls around pipe located on both the waterside (WS) and landside (LS) shoulders. Flap gate is located on the WS end. Slide gate is located on the LS. Concrete headwall, saddle and apron are located on the WS end. [Additional Reference(s): DWR Levee Log, 2005. USACE Sacramento O&M Manual Unit No. 151, May 1953, Station 471+21].

Marker visible on WS shoulder, crossing referenced as No. 14.

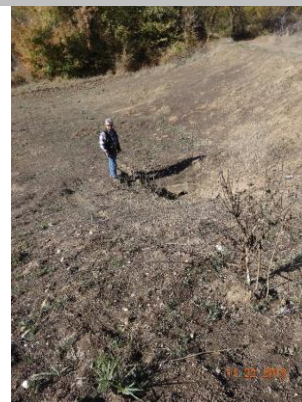
Photo 2 of 2 : UCIP\_FA\_2016\_50059\_44692.jpg

View of WS slope.

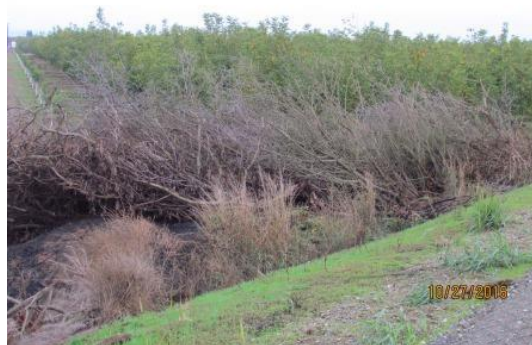
Photo 1 of 1 : FA\_2016\_RD0010\_164\_58\_20161102\_00103.jpg

View of pruning's stacked up at landside levee toe. Fall 2016.

| Remove pruning's from toe. Fall 2016. | | | | | |

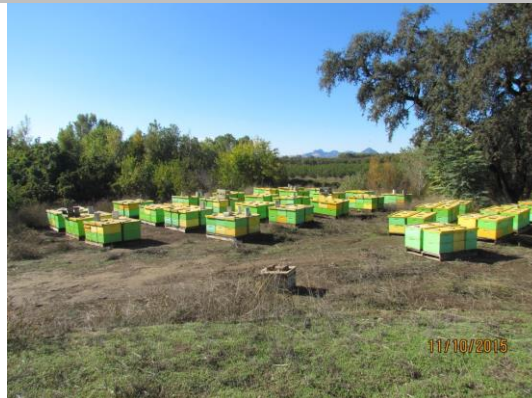
Photo 1 of 1 : FA\_2016\_RD0010\_164\_34\_20160906\_00009.jpg

| Bee hives have been placed on a wide section of the crown. | | | | | |

View of the beehives on the crown of the levee. Fall 2015.

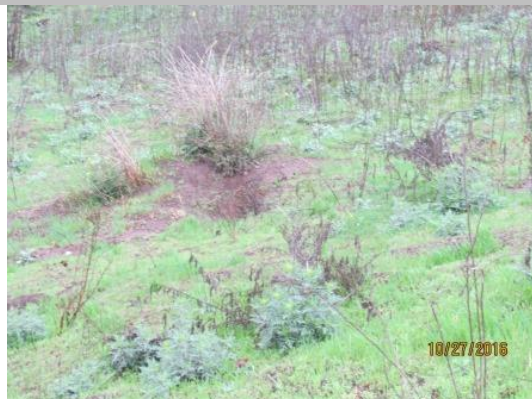
Photo 1 of 1 : FA\_2016\_RD0010\_164\_35\_20161102\_00105.jpg

View of rodent hole on waterside. Fall 2016.

| Back fill rodent hole. Fall 2016. | | | | | |

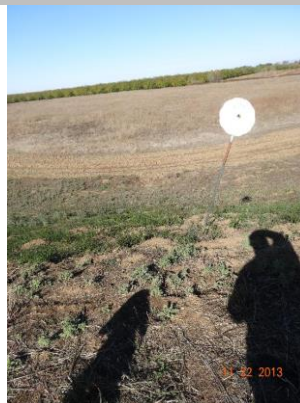
Photo 1 of 2 : UCIP\_FA\_2016\_27775\_51473.jpg

| UCIP Comments: Sediment build-up at the inlet--recommend clearing sediment. This crossing is referenced in the USACE Periodic Inspection as item USACE_CESPK_HON2_2013_p_0348. | | | | | |

View of waterward side.

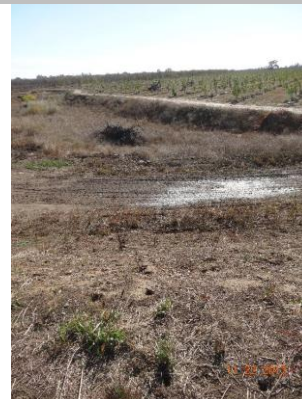
Photo 2 of 2 : UCIP\_FA\_2016\_27775\_51472.jpg

| UCIP Comments: Sediment build-up at the inlet--recommend clearing sediment. This crossing is referenced in the USACE Periodic Inspection as item USACE_CESPK_HON2_2013_p_0348. | | | | | | |

View of landward side.

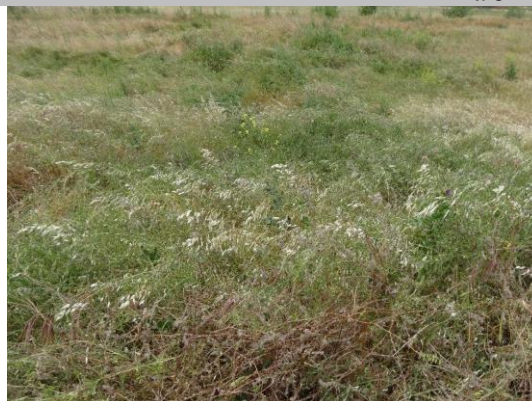
Photo 1 of 2 : UCIP\_FA\_2016\_24768\_44450.jpg

| FS_ID:24768<br>DS_ID:21298<br>EP_NO: N/A<br>Repair Type: Non-Urgent<br>Crossing Status: Found<br>UCIP Comments: Crossing is buried--found indicators of concrete headwall. Need to contact owner to determine status of crossing. This crossing is referenced in the USACE Periodic Inspection as item USACE_CESPK_HON2_2013_p_0378.<br>FIELD_STRUCT_DESC: 24-inch CM drainpipe through the levee, 13.0 feet below the crown. Two CM cutoff walls around pipe at both shoulders. Flap gate on the waterward end. Slide gate on the landward end. Concrete headwalls at both ends. Metal marker on waterward slope. (USACE-1953). This entry matches the Drainage or Irrigation Structure referenced in O&M manual (Station 576+75).<br>FS Date: 4/30/2013 | | | | | |

View of waterward slope.

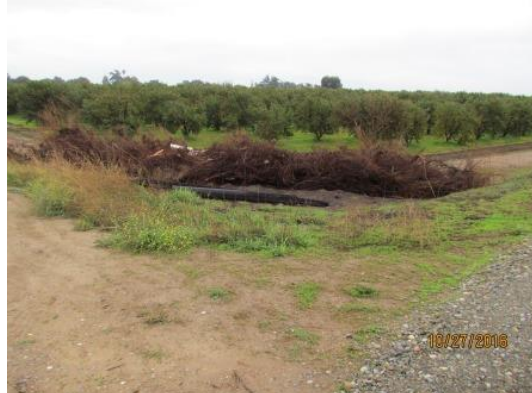
Photo 1 of 1 : FA\_2016\_RD0010\_164\_69\_20161103\_00111.jpg

View of large pile of pruning's on the landside levee toe looking downstream. Fall 2016.

| Remove pruning's from levee toe. Fall 2016. | | | | | |

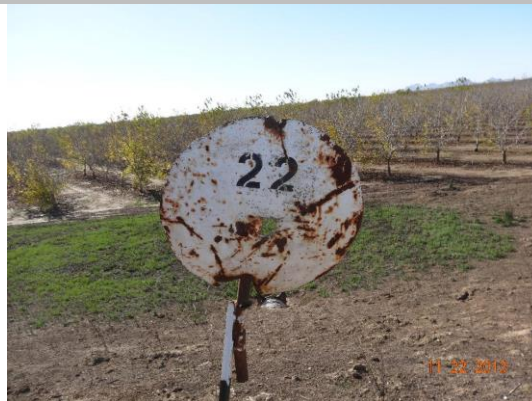
Photo 1 of 2 : UCIP\_FA\_2016\_27776\_51478.jpg

| UCIP Comments: Recommend removing debris blocking slide gate on landward side. This crossing is referenced in the USACE Periodic Inspection as item USACE_CESPK_HON2_2013_p_0402. | | | | | |

Marker visible on waterward shoulder, crossing referenced as No. 22.

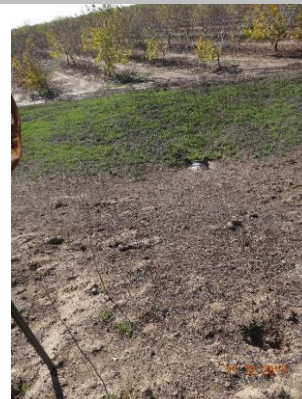
Photo 2 of 2 : UCIP\_FA\_2016\_27776\_51482.jpg

View of waterward side.

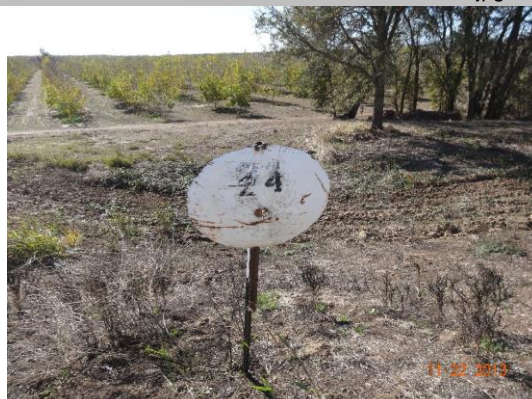
Photo 1 of 2 : UCIP\_FA\_2016\_24838\_44737.jpg

| FS_ID:24838<br>DS_ID:21303<br>EP_NO: 1069<br>Repair Type: Non-Urgent<br>Crossing Status: Found<br>UCIP Comments: Unable to find the crossing on landward side--indicators found of crossing. Need to coordinate with owner to determine status of crossing. If crossing is no longer in use owner will need to contact the CVFPB to comply with Title 23. This crossing is referenced in the USACE Periodic Inspection as item USACE_CESPK_HON2_2013_p_0442.<br>FIELD_STRUCT_DESC: 24-inch steel pipe through the levee, 13.0 feet below the crown. Two concrete cutoff walls around pipe at both shoulders. Flap gate and concrete headwall on waterward end. Slide gate and concrete saddle and apron on landward end. (Permit No. 1069-1941) This entry matches the Drainage or Irrigation Structure referenced in O&M manual (Station 638+00).<br>FS Date: 4/30/2013 | | | | | |

Marker visible on waterward shoulder, this crossing is reference as No. 24.

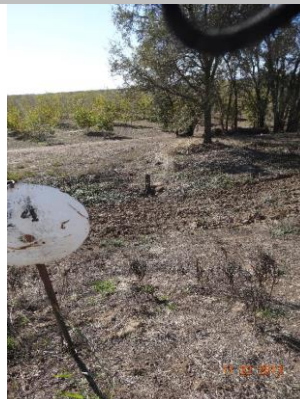
Photo 2 of 2 : UCIP\_FA\_2016\_24838\_44741.jpg

| FS_ID:24838<br>DS_ID:21303<br>EP_NO: 1069<br>Repair Type: Non-Urgent<br>Crossing Status: Found<br>UCIP Comments: Unable to find the crossing on landward side-- indicators found of crossing. Need to coordinate with owner to determine status of crossing. If crossing is no longer in use owner will need to contact the CVFPB to comply with Title 23. This crossing is referenced in the USACE Periodic Inspection as item USACE_CESPK_HON2_2013_p_0442.<br>FIELD_STRUCT_DESC: 24-inch steel pipe through the levee, 13.0 feet below the crown. Two concrete cutoff walls around pipe at both shoulders. Flap gate and concrete headwall on waterward end. Slide gate and concrete saddle and apron on landward end. (Permit No. 1069-1941) This entry matches the Drainage or Irrigation Structure referenced in O&M manual (Station 638+00).<br>FS Date: 4/30/2013 | | | | | |

View of waterward side.

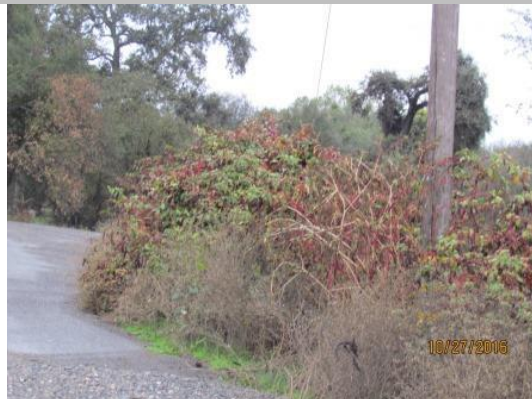
Photo 1 of 1 : FA\_2016\_RD0010\_164\_76\_20161103\_00119.jpg

View looking downstream at wild growth on waterside slope that needs to be removed. Fall 2016.

| Wild growth on waterside slope should be removed. Fall 2016. | | | | | |

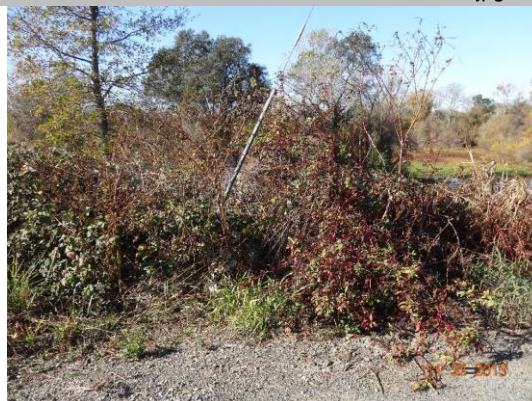
Photo 1 of 2 : UCIP\_FA\_2016\_24839\_44745.jpg

| FS_ID:24839<br>DS_ID:21304<br>EP_NO: N/A<br>Repair Type: Non-Urgent<br>Crossing Status: Found<br>UCIP Comments: Rip rap was used to stabilize the waterward slope during high water as a means of emergency repair--unable to determine storm event when repair was performed. Recommend obtaining records of the repair and to determine if crossing is still being used. Need to determine owner. Dense vegetation limits the inspector's visibility to identify signs of pipe failure (leaks) along the slope. Recommend removing vegetation along pipe alignment to conduct proper inspection of structure and appurtances. This crossing is referenced in the USACE Periodic Inspection as item USACE_CESPK_HON2_2013_p_0458 and 460.<br>FIELD_STRUCT_DESC: 24-inch steel pipe through the levee, 5.0 feet below the crown. Slide gate in a 36-inch concrete riser on the landward shoulder. Gate valve in a pump house on the waterward slope. Concrete headwall, saddle and apron on the waterward end. (USACE-1953). This entry matches the Drainage or Irrigation Structure referenced in O&M manual (Station 655+65).<br>FS Date: 4/30/2013 | | | | | |

View of waterward shoulder behind vegetation is standpipe.

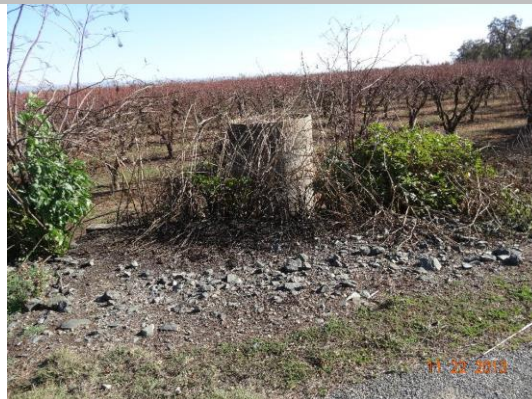
Photo 2 of 2 : UCIP\_FA\_2016\_24839\_44742.jpg

| FS_ID:24839<br>DS_ID:21304<br>EP_NO: N/A<br>Repair Type: Non-Urgent<br>Crossing Status: Found<br>UCIP Comments: Rip rap was used to stabilize the waterward slope during high water as a means of emergency repair--unable to determine storm event when repair was performed. Recommend obtaining records of the repair and to determine if crossing is still being used. Need to determine owner. Dense vegetation limits the inspector's visibility to identify signs of pipe failure (leaks) along the slope. Recommend removing vegetation along pipe alignment to conduct proper inspection of structure and appurtances. This crossing is referenced in the USACE Periodic Inspection as item USACE_CESPK_HON2_2013_p_0458 and 460.<br>FIELD_STRUCT_DESC: 24-inch steel pipe through the levee, 5.0 feet below the crown. Slide gate in a 36-inch concrete riser on the landward shoulder. Gate valve in a pump house on the waterward slope. Concrete headwall, saddle and apron on the waterward end. (USACE-1953). This entry matches the Drainage or Irrigation Structure referenced in O&M manual (Station 655+65).<br>FS Date: 4/30/2013 | | | | | | |

View of standpipe located on landward side.

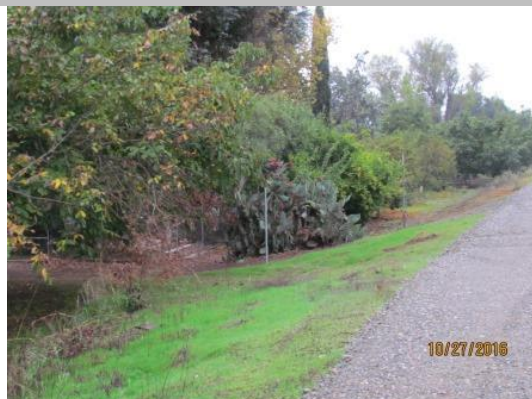
Photo 1 of 1 : FA\_2016\_RD0010\_164\_37\_20161103\_00121.jpg

View of the cactus on the landward side of the levee looking downstream. Fall 2016.

| Landscaping on levee toe should be removed. Fall 2016. | | | | | |

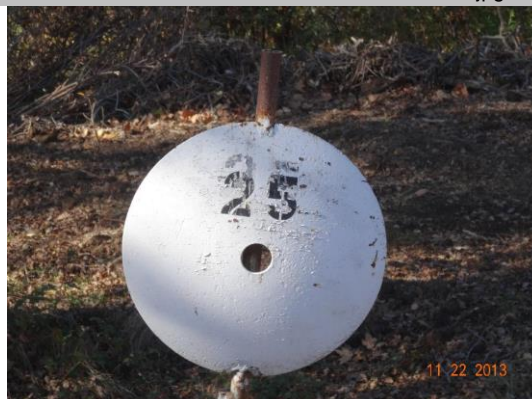
Photo 1 of 2 : UCIP\_FA\_2016\_24840\_44753.jpg

| UCIP Comments: Burrow activity--large holes found on landward side. | | | | | |

Marker visible on waterward side, crossing is referenced as No. 25.

| Crossing on landward side is blocked. Recommend clearing headwall | | | | | |

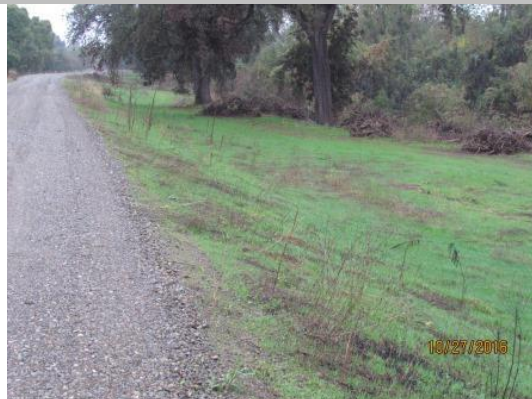
Photo 1 of 1 : FA\_2016\_RD0010\_164\_78\_20161103\_00123.jpg

| No squirrel activity and holes have been backfilled. Fall 2016. | | | | | |

View of the waterside looking downstream where the rodent hole have been backfilled. Fall 2016.

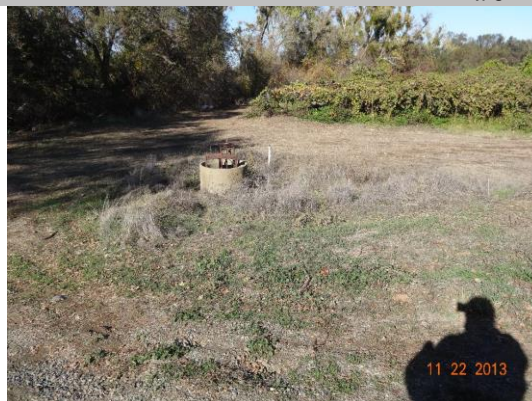
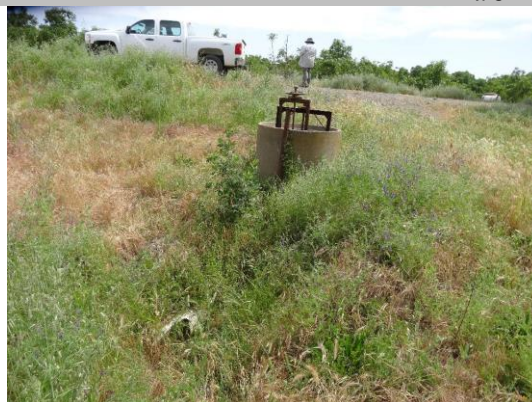
FS\_ID:24841  
DS\_ID:21306  
EP\_NO: N/A  
Repair Type: Non-Urgent  
Crossing Status: Found  
UCIP Comments: Debris found inside crossing--recommend removing it.  
FIELD\_STRUCT\_DESC: 24-inch CM pipe through the levee, 6.0 feet below the crown. Slide gate in concrete standpipe on the waterward end.  
FS Date: 5/1/2013

View of waterward side.

View of concrete standpipe and plastic pipe extension visible on waterward side.
